In-vitro Fatigue Testing Of Thermally Sprayed Hydroxyapatite Coatings

Gledhill, Heather Claire

submitted by Heather Claire Gledhill

for the degree of PhD
of the University of Bath

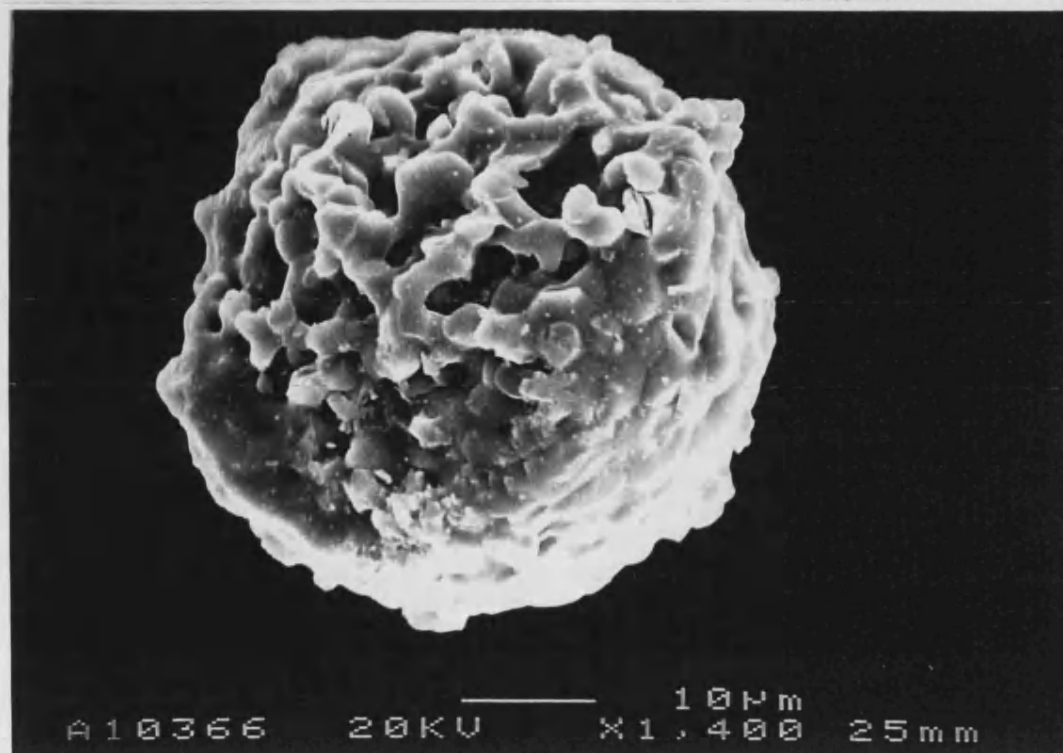
The DGUN HA spray powder (Figure 4-3) has a very different morphology to that of the VPS powder. These particles, although again apparently highly porous are much more spherical in nature and were probably manufactured by a spray drying route. Again, although X-ray diffraction studies reveal the particles to be highly crystalline in nature, their surfaces, like the VPS particles, show significant areas of smooth, glassy material. These powder spheres appear to be composed of agglomerates of smaller particles fused into single discrete balls. The particles are also much smaller in size than the material used in the manufacture of VPS coatings, being on average approximately 50 μm in diameter.

Figure 4-3 :- Scanning electron micrograph showing DGUN HA spray powder

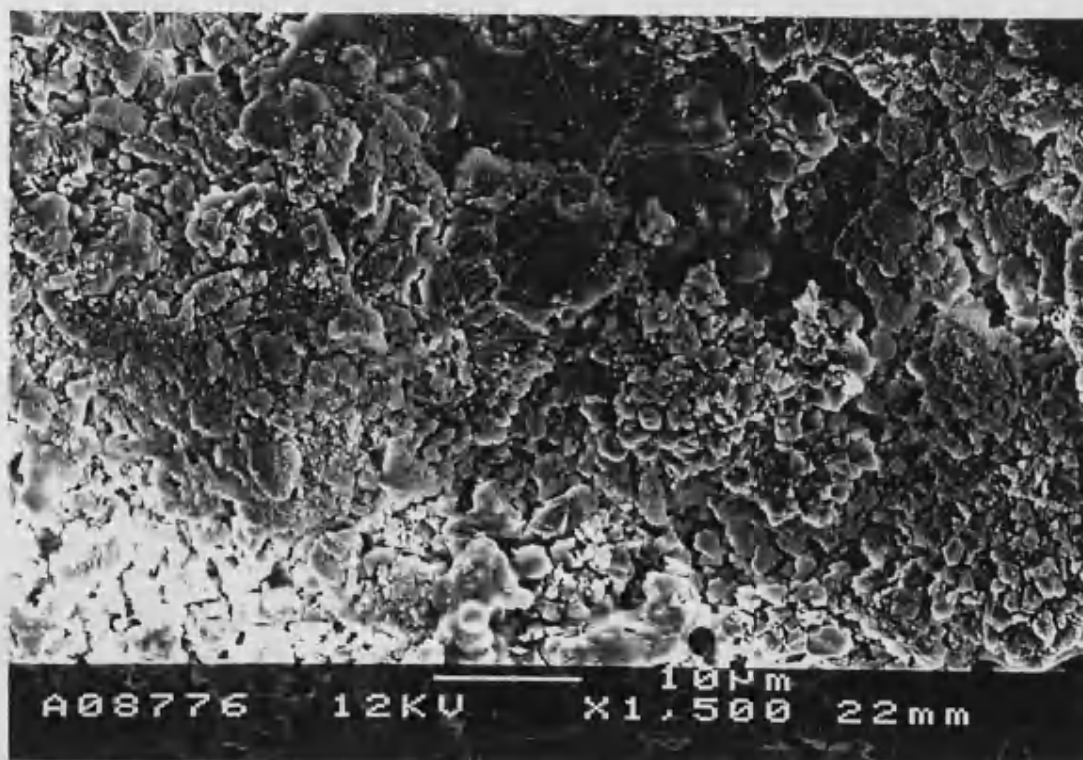
Figure 5-4 :- Scanning electron micrograph showing surface of VPS HA coating aged unloaded pH 7.2
x 1 week

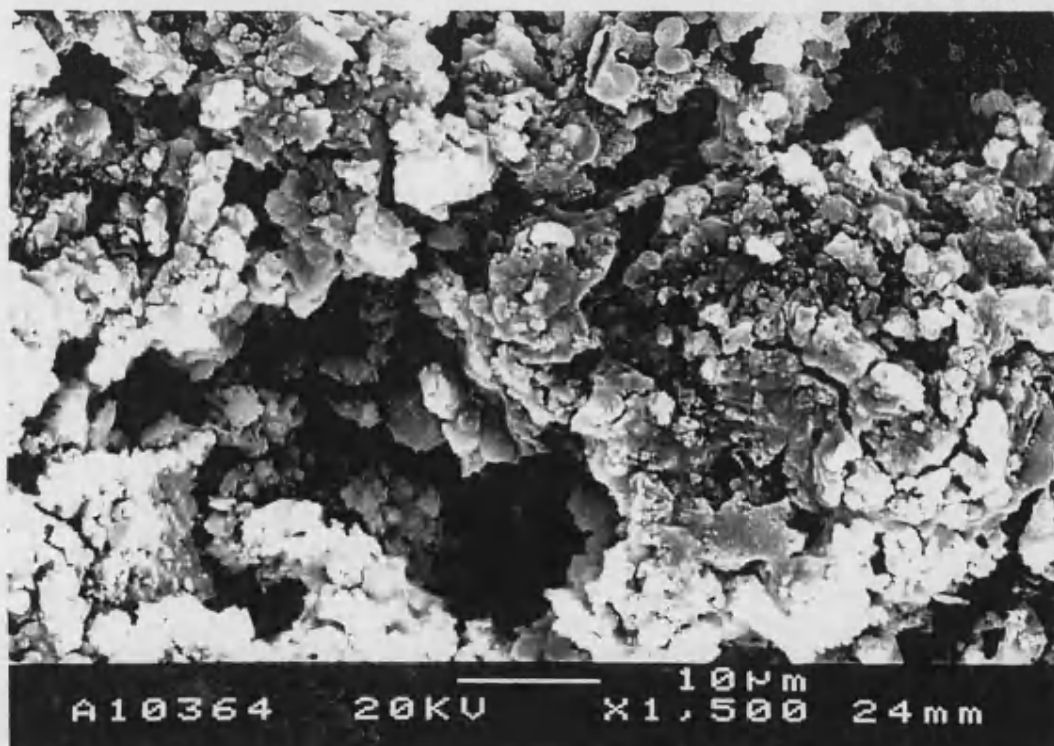
Figure 5-20 :- Scanning electron micrograph showing surface of DGUN HA coating aged unloaded pH 4.5 x8 weeks

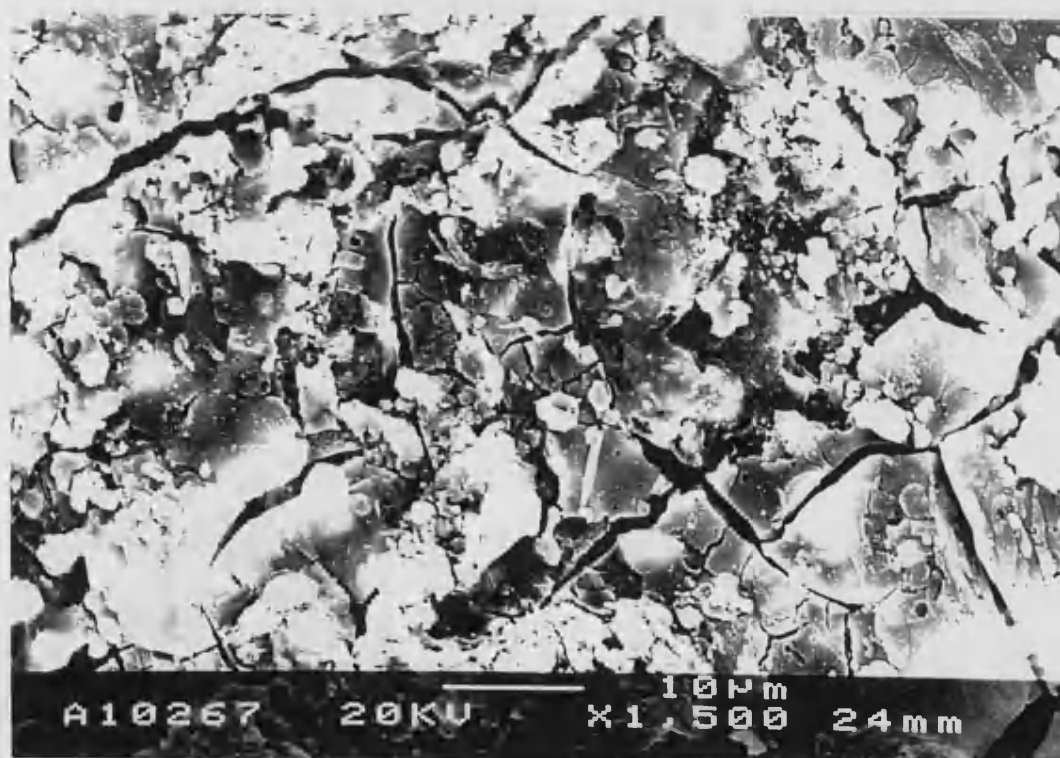
Figure 6-25 :- Scanning electron micrograph showing surface of DGUN HA coating aged under static loading at pH 4.5 for one week

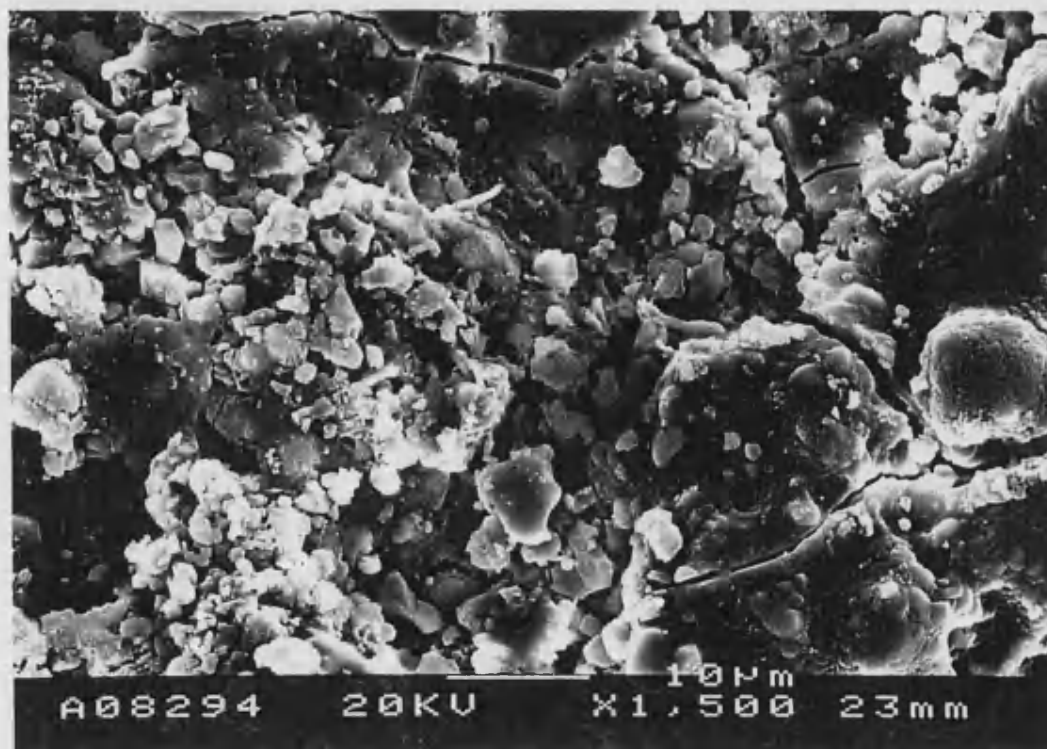
Figure 7-6 :- Scanning electron micrograph showing surface of VPS HA coatings fatigued in air for ten million cycles

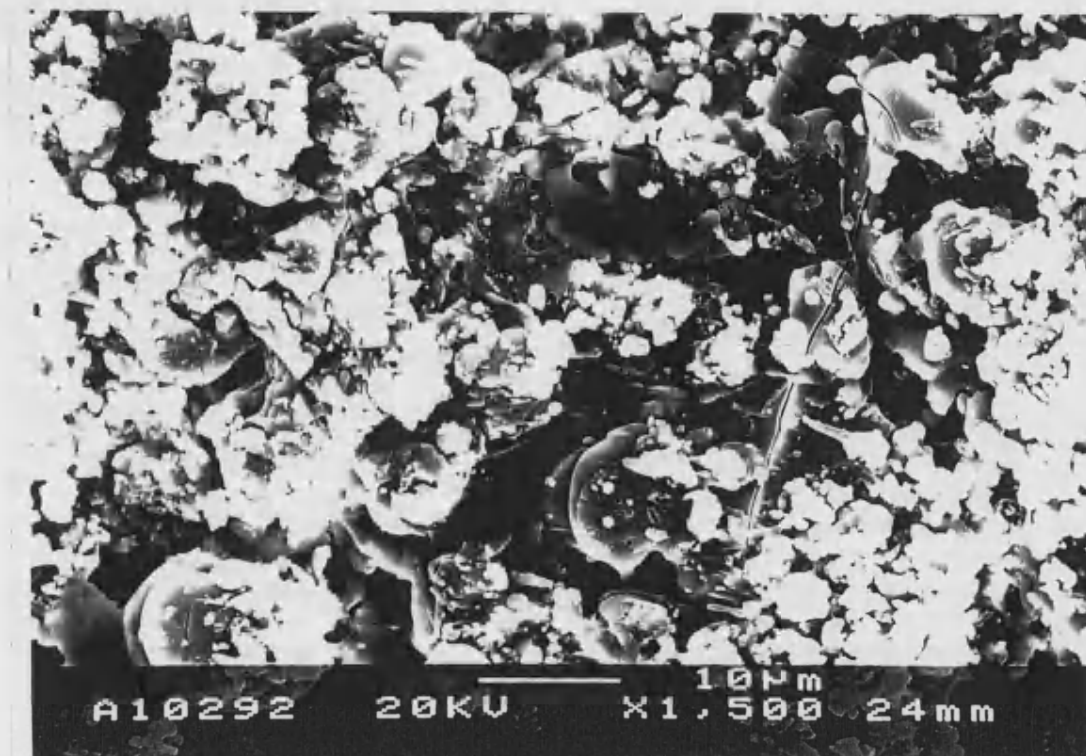
Figure 7-14 :- Scanning electron micrograph showing surface of DGUN HA coatings fatigued in air for ten million cycles

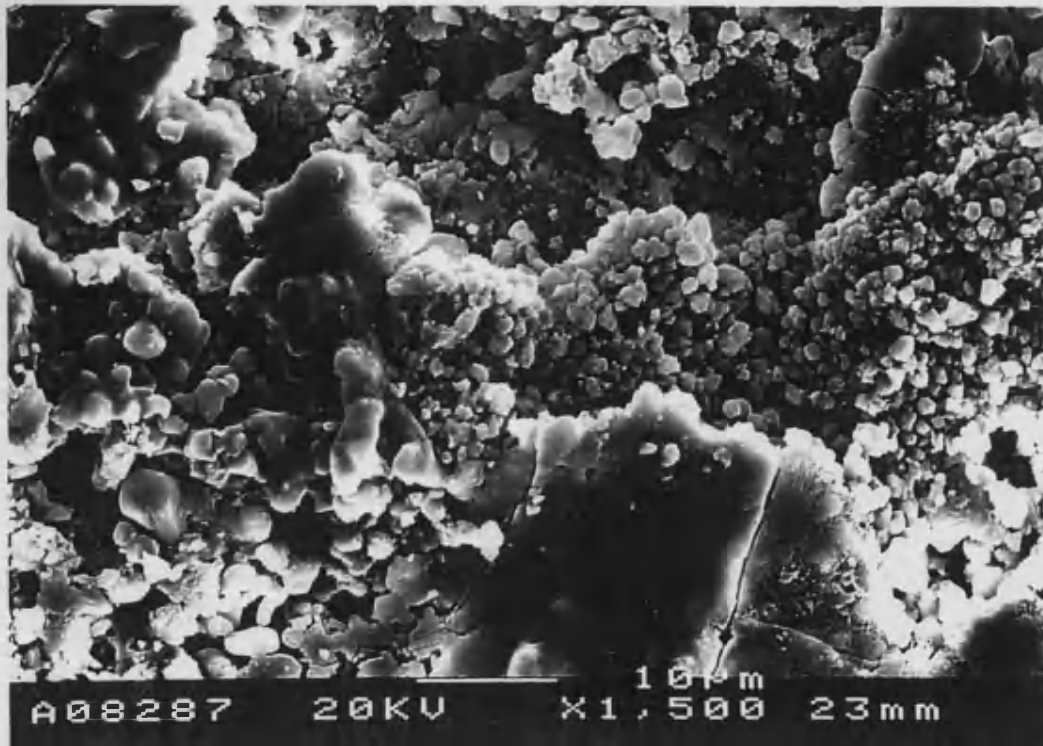
Figure 7-21 :- Scanning electron micrograph showing surface of VPS HA coatings aged for twelve weeks then fatigued in Ringer's solution

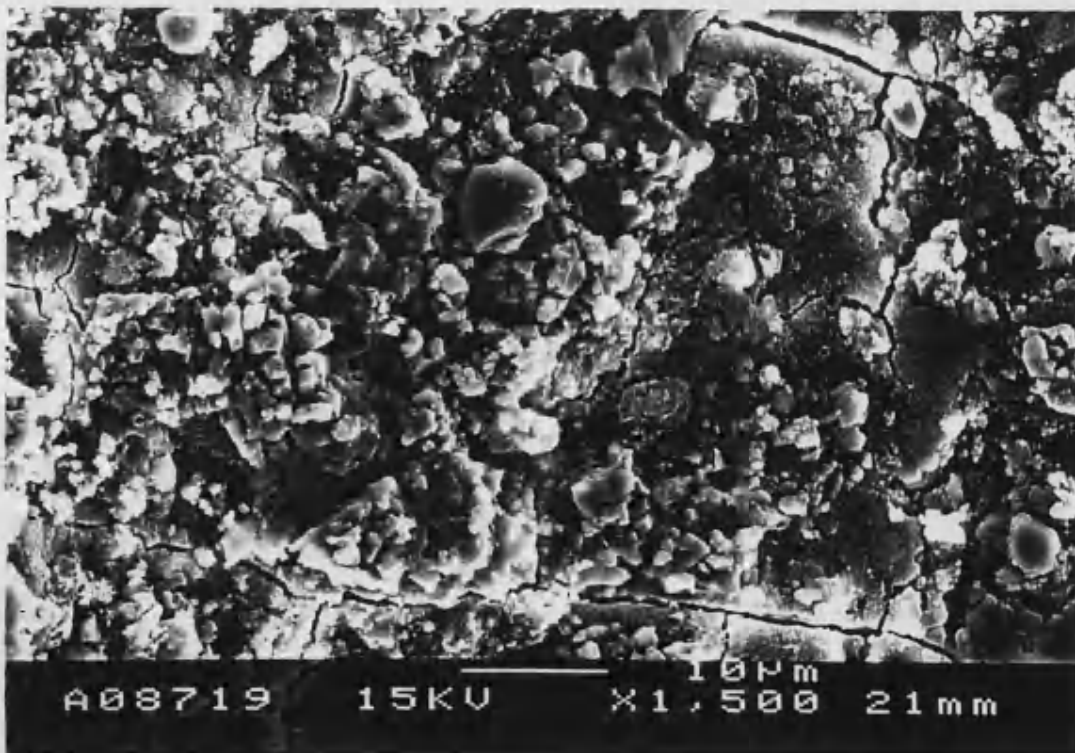
Figure 7-25 :- Scanning electron micrograph showing surface of DGUN HA coatings aged for one week then fatigued in Ringer's solution

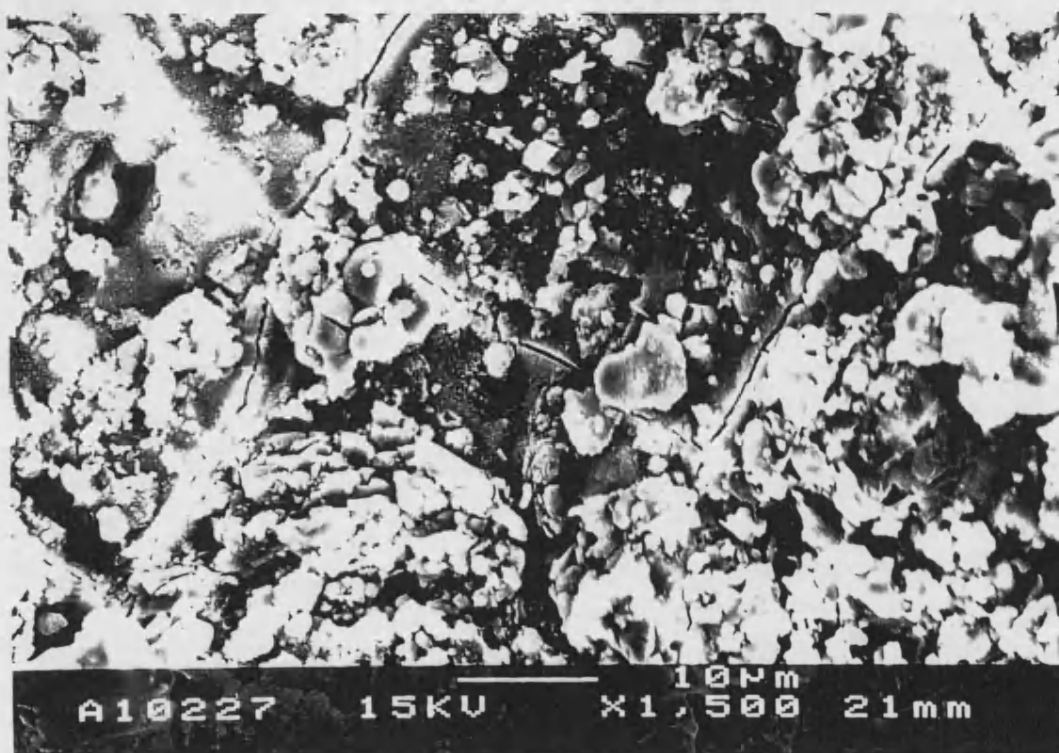
Figure 7-26 :- Scanning electron micrograph showing surface of DGUN HA coatings aged for twelve weeks then fatigued in Ringer's solution
